INSPECTION REPORT: GREENS CREEK MINE

Date of Inspection: Tuesday July 18, 2017
Date of Report: Friday July 28, 2017
USDA Forest Service Inspector: Richard Dudek

Ranger District: Admiralty National Monument, Juneau Ranger District
Weather Conditions: Cloudy with rain. Temperature: mid 50's (°F).

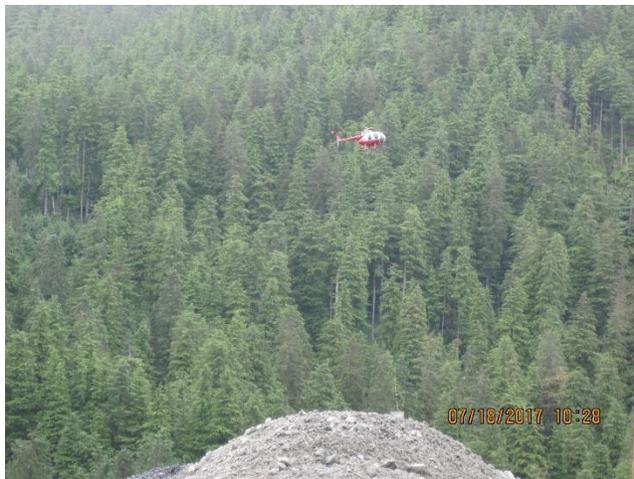
HGCMC is currently conducting surface exploration work at the Gallagher drilling sites (Photo 1). This is part of HGCMC's approved five-year (2017-2021) Surface Exploration Plan of Operations.

Photo 1. A support helicopter for surface exploration.

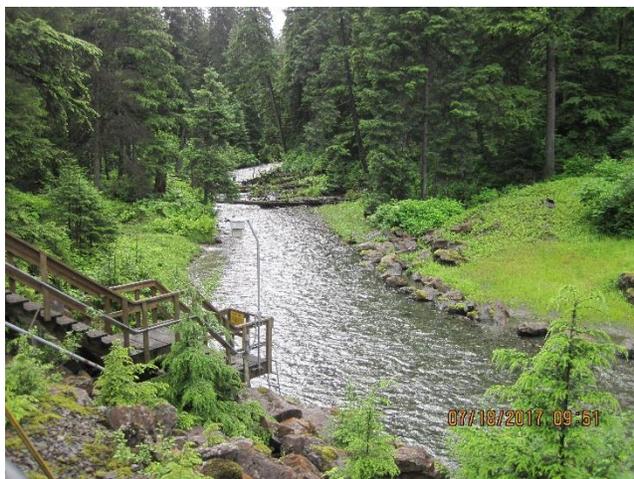
The flow for Greens Creek (Photo 2) at the 920 weir was 69 cubic feet per second (cfs). The daily fresh water withdrawal for the 920 system remains at 1.5 cfs (700 gpm) (Appendix 10; 3.1).

Photo 2. Greens Creek

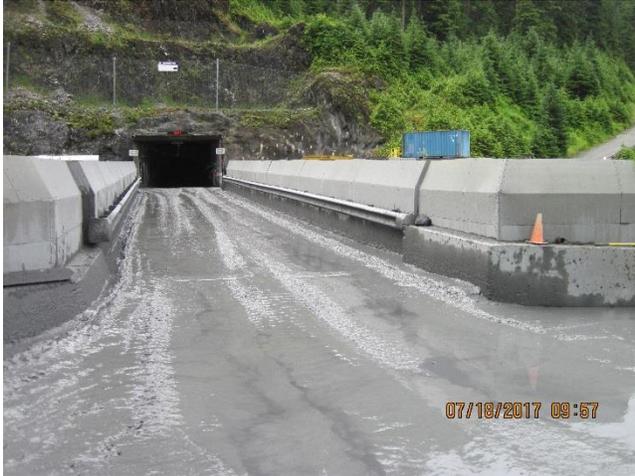
The 920 bridge's splashguards are effectively working by preventing sediment splash over into Greens Creek (Photo 3).

Photo 3. The 920 bridge.

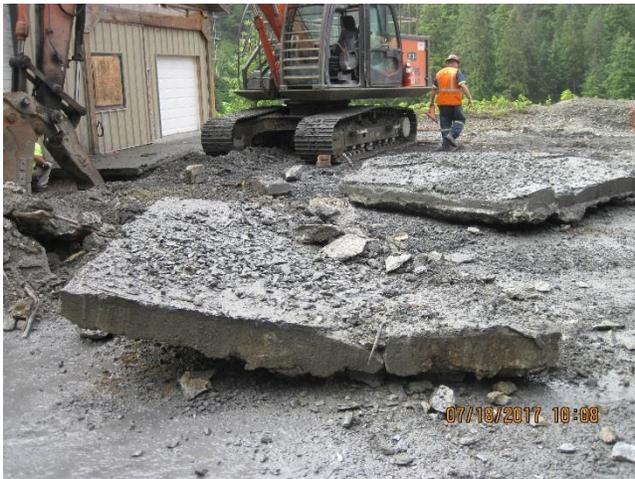
HGCMC has begun construction for the 920 warehouse expansion (Photo 4).

Photo 4. Excavation has begun for the 920 warehouse expansion.

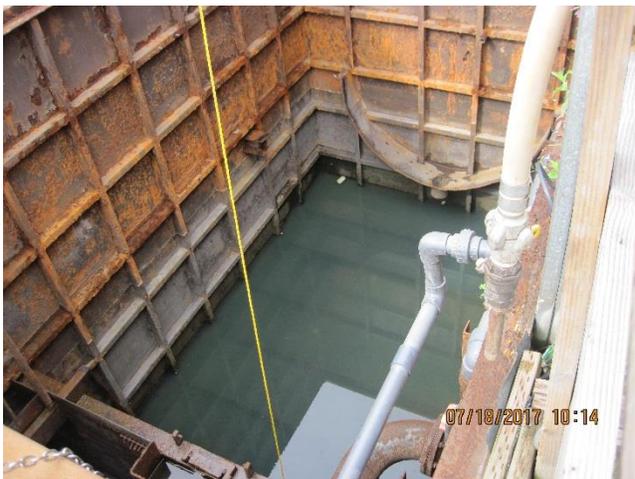
HGCMC civil engineers have completed the structural integrity project for the 920 sewer lift station (Photo 5).

Photo 5. 920 sewer lift station.

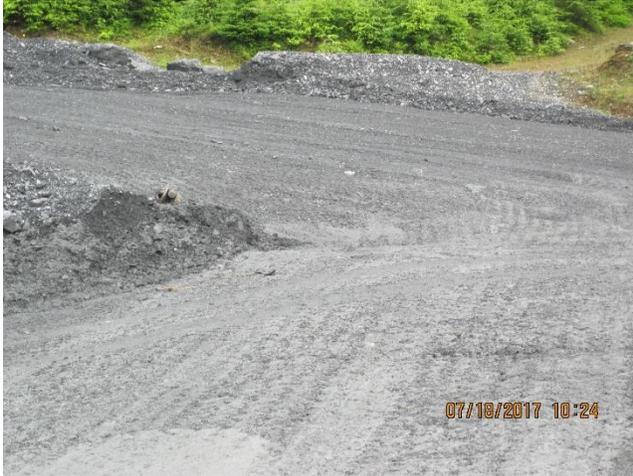
HGCMC recently removed Class 1 waste rock "Argillite" (Photo 6) to the northern eastern outer slopes of the TDF area. Class 1 waste rock is primarily used as a rock armor for the outer slopes to prevent fugitive dust, and serves as an acid neutralizing cover layer for potential acid generating waste rock. (Appendix 1; Section 3.1).

Photo 6. Class 1 waste rock at Site 23.

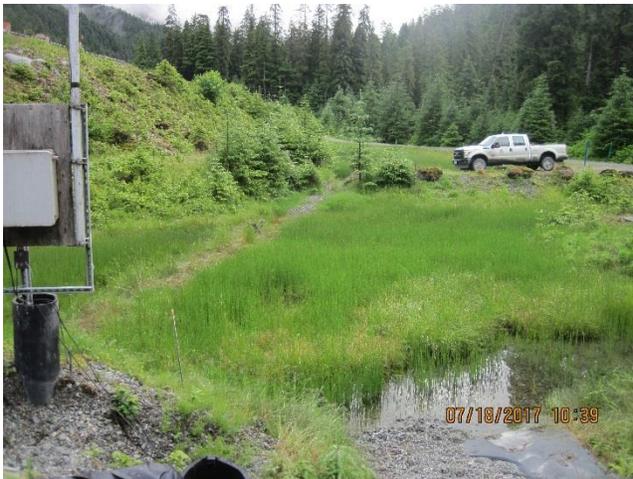
Pond D's (Photo 7) water level was minimal and this site was well kept and in order.

Photo 7. Pond D (Outfall 006).

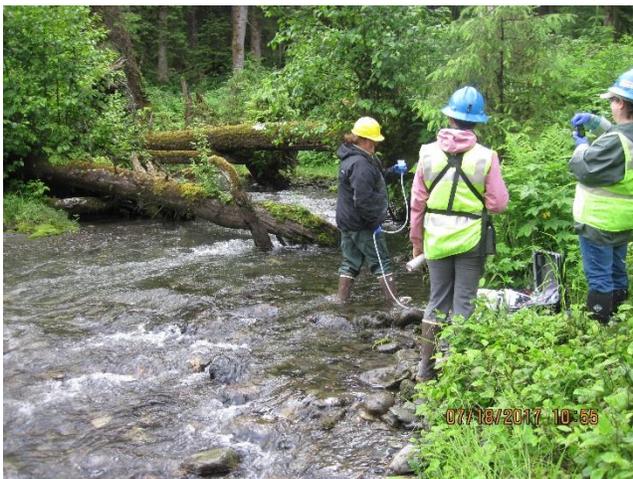
During Bio-monitoring in 2015 and 2016, Coho salmon were observed in Greens Creek at Fresh Water Monitoring Program (FWMP) Site 54. On 7/18/2017, the US Forest Service biologists conducted a fish eDNA test (Photo 8) at site 54 for Coho DNA. The results from the eDNA test will indicate if Coho are present beyond the 5.0 mile B-road natural barrier (fish pass).

Photo 8. An eDNA test at FWMP site 54.

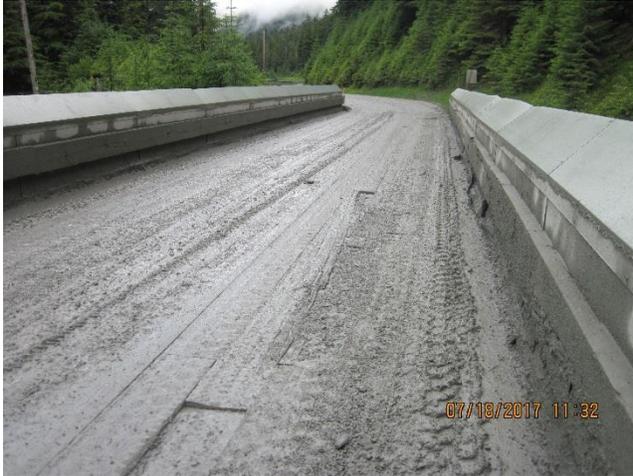
Photo 9. 7.4 mile B-road Bridge (Killer Creek Bridge).

HGCMC personnel will be re-decking/relining the bridge in late July, 2017 (Photo 9). The splashguards are effectively working by preventing sediment splash over from vehicle traffic (Photo10). HGCMC Surface operations recently hydroseeded the bridge's downhill side abutment (Photo 11). HGCMC anticipates the vegetative cover will help filter out sediments from surface runoff.

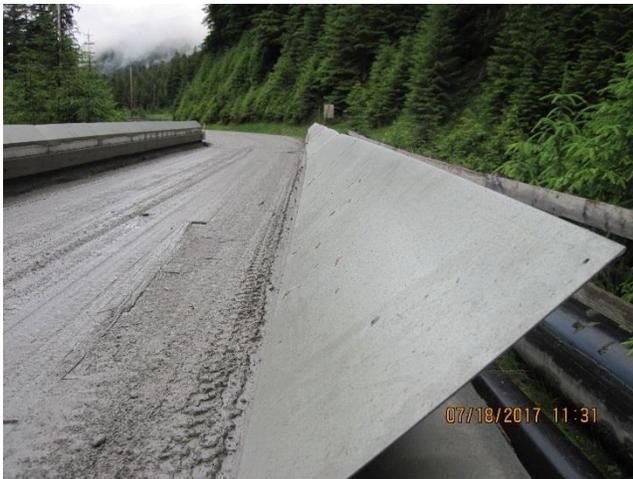
Photo 10. 7.4 mile B-road Bridge splashguards.

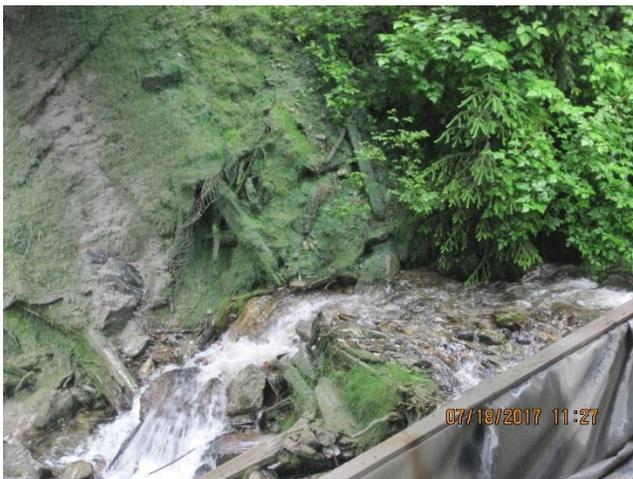
Photo 11. 7.4 mile B-road bridge's downhill side abutment was recently hydroseeded.

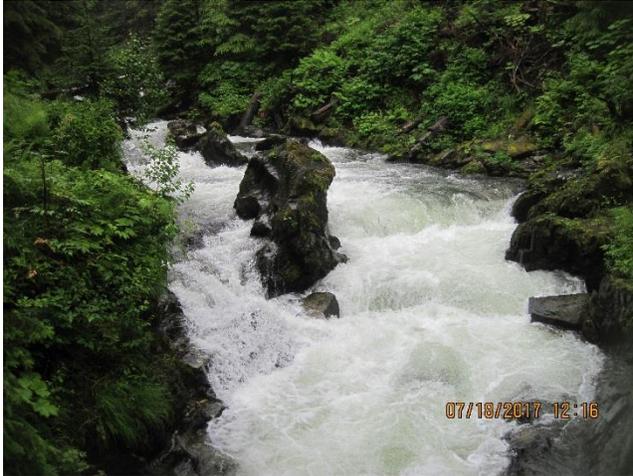
The fish passage (Photo 12) was reconstructed on Greens Creek as a mitigation requirement in the 2013 TDF Expansion Final Environmental Impact Statement and Record of Decision. The reconstruction included installing three concrete steel-capped weirs. HGCMC was issued a fish habitat permit (FH11-I-0123) by the Alaska Department of Fish and Game (ADF&G). This permit authorizes HGCMC to maintain the fish pass as long as tailings block fish passage in the Tributary Creek headwaters. While on site, one Dolly Varden char were observed downstream of the fish pass bridge (Photo 13). ADF&G Habitat biologists will continue Bio-monitoring upstream to determine if anadromous fish can transit beyond this natural barrier.

Photo 12. 5.0 mile B-road Fish Pass.

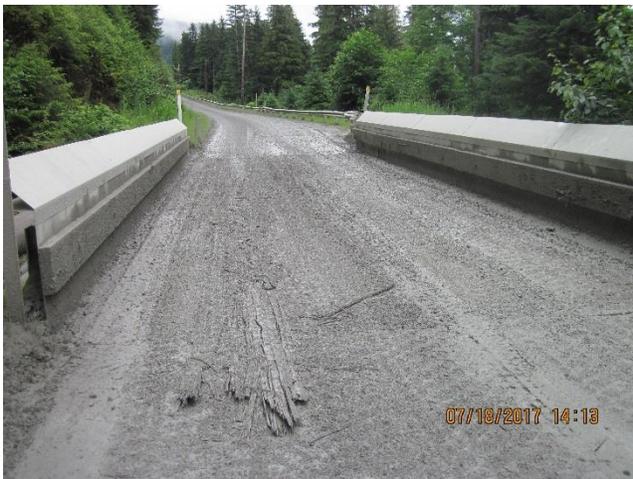
Photo 14. 3.4 mile B-road Bridge (Falls Creek Bridge).

HGCMC Surface operations have scheduled the bridge to re-decked and relined in late July, 2017 (Photo 14). During the re-decking/relining, the temporary sediment barrier (Photo 15) will be cleaned. The temporary sediment barrier meets the same maintenance criteria as silt fencing. When sediment accumulation reaches one-third of the structure's height, the sediments are removed and the structure is cleaned (Appendix 5 BMP plan page BMP-12).

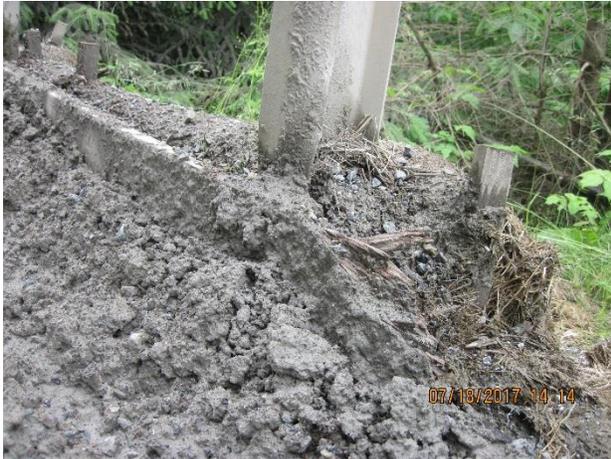
Photo 15. The 3.4 mile B-road temporary sediment barrier (Falls Creek Bridge).

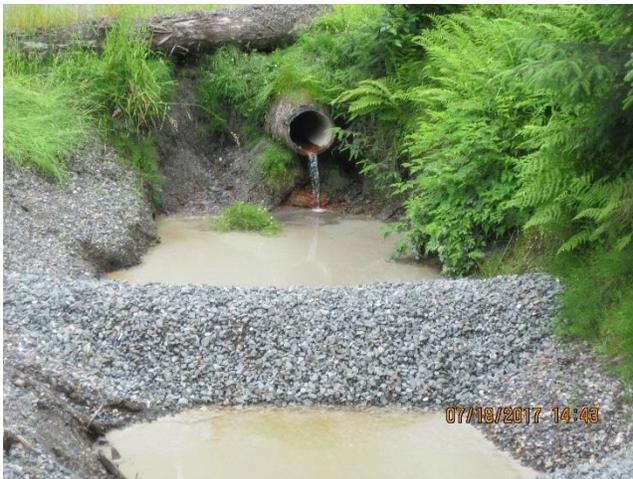
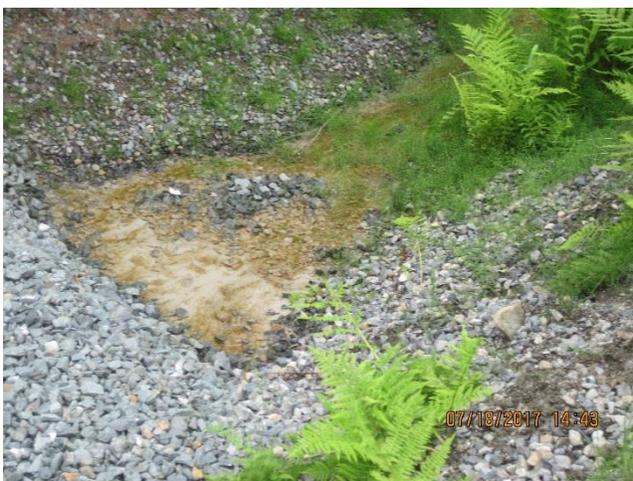
During the previous inspection on 6/8/2017, turbid water was observed past the culvert's structural BMP's (Photos 16-17). During this inspection, clear water was entering the culvert, and clear water was flowing from the BMP's, then into the vegetation. During and after each rainfall event, HGCMC personnel inspect and conduct any necessary maintenance on culverts and the structural BMP's (Appendix 5 BMP plan page BMP 6-7).

Photo 16. The 3.2 mile B-road culvert.

Photo 17. 3.2 mile B-road rock check dam.

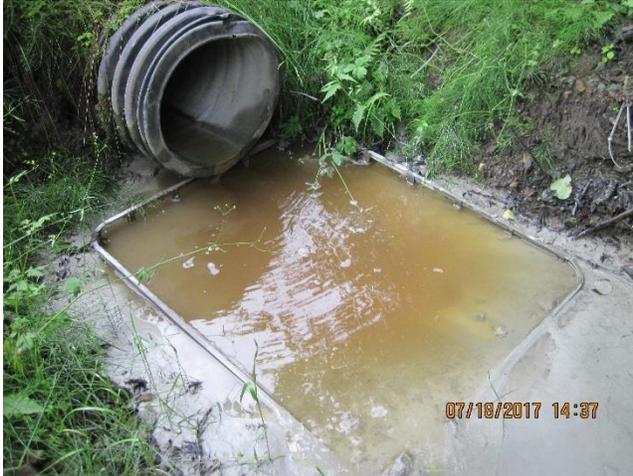
Due to recent rain events and sediment loading, the removable sediment screen is near capacity (Photo 18). HGCMC Surface operations will replace the screen when the sediment accumulation reaches 75 percent.

Photo 18. The 3.1 mile B-road removable sediment screen.

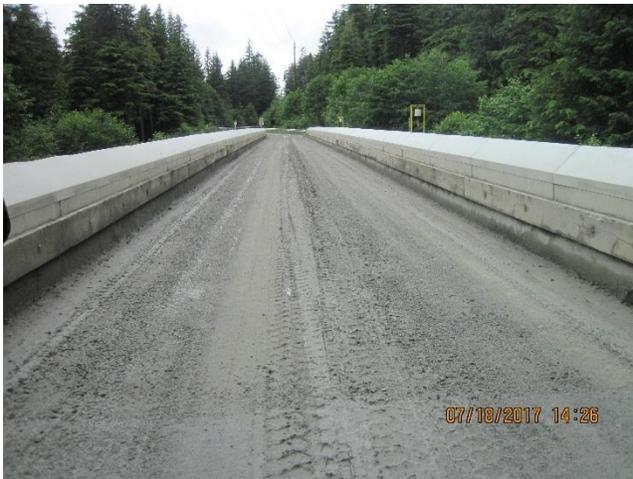
Photo 19. 3.0 mile B-road Bridge (Zinc Creek Bridge).

HGCMC Surface operations will begin re-decking and relining the bridge (Photo 19) in late July, 2017.

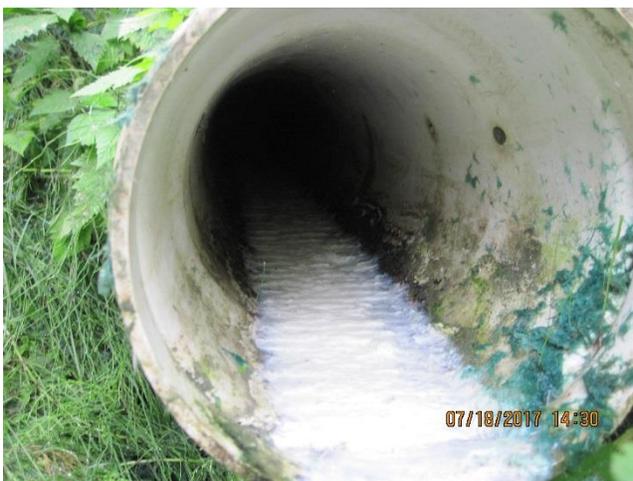
White material was observed on the ground and inside the drain for the uphill side abutment (Photo 20). HGCMC conducted an X-ray diffraction (XRD) test on the white material, and the results suggest the composition of the precipitate is quartz (SiO_2) and aluminum (Al).

Photo 20. The white precipitate is composed of quartz and aluminum.

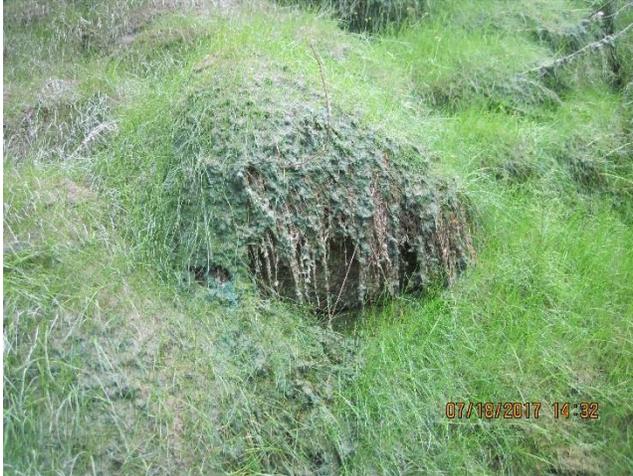
HGCMC Surface operations have recently hydroseeded the uphill side abutment of the bridge (Photo 21). Hydroseeding is a mitigation used for soil slope stability, which will help reduce erosion damage caused by stormwater runoff (Appendix 5 BMP plan; page 13).

Photo 21. Hydroseeded abutment

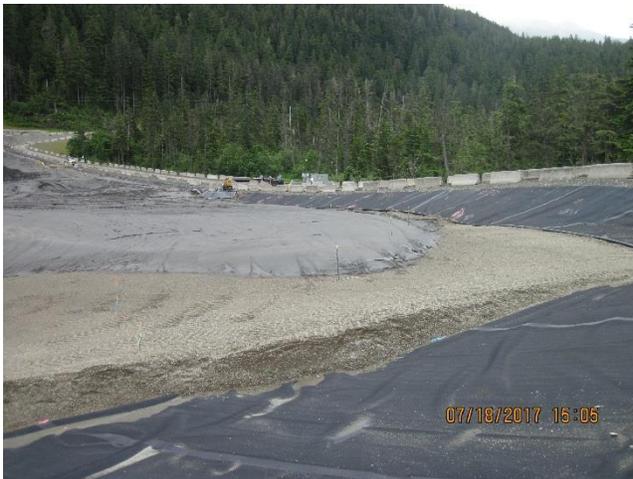
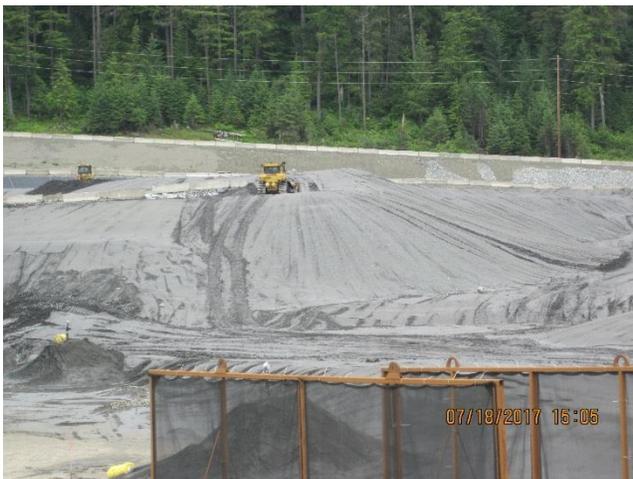
HGCMC continues to place tailings in the S3P1 area (Photos 22-23).

Photo 22. The S3P1 expansion area (Image 1 of 2).

Photo 23. The S3P1 expansion area (Image 2 of 2).

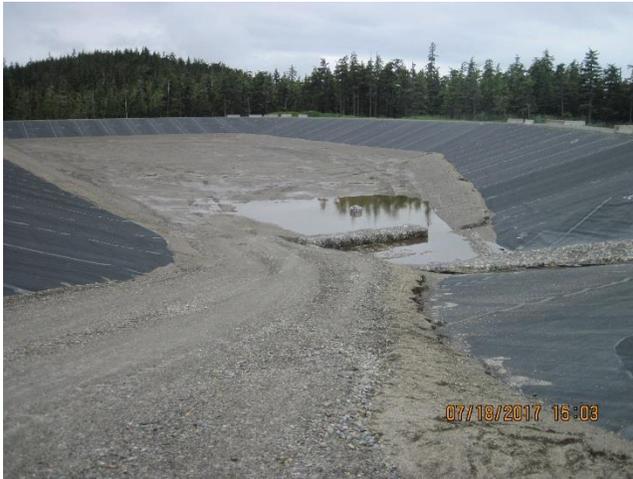
Photo 24. TDF area Pond 10.

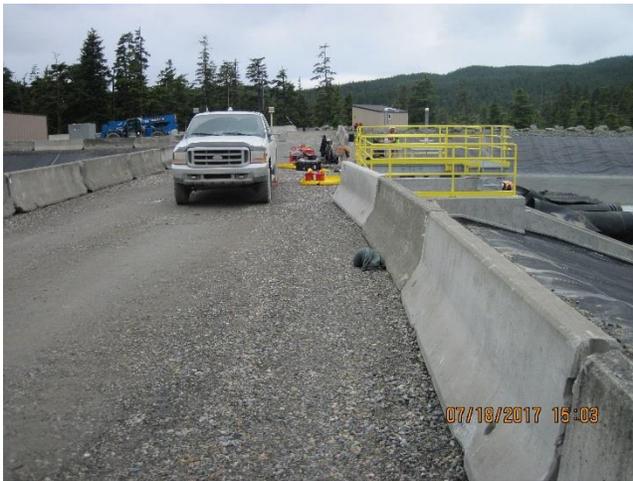
The construction for Pond 10 (Photo 24) is complete, and the contractors are in the final construction stage for the concrete flow structure (Photo 25). HGCMC is currently engaged in the review process with the Alaska Department of Natural Resources (ADNR) Alaska Dam Safety Program for approval to use Pond 10 and the concrete flow control structure.

Photo 25. Concrete flow structure.
